CONDITION SURVEY DIAMOND ISLAND FERRY

Diamond Island Ferry

Ultrasonic Gauging

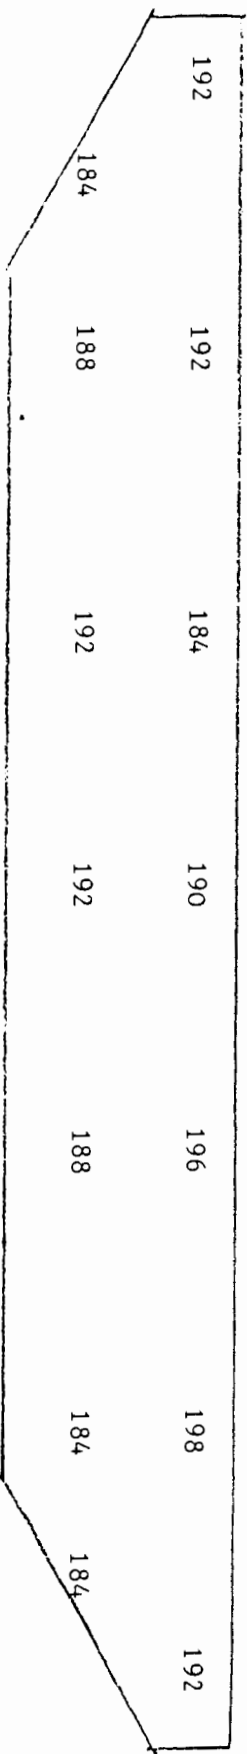
Outboard Profile

Examination of the vessel's hull revealed a relatively uniform loss of plate thickness, approximating 25% of original, generally from in way of the wind/water line and below. Plate thicknesses above the wind/water line generally exhibited losses of less than 10% of original.

Port side shell plating

It is the opinion of the undersigned surveyor that the extreme heavy accumulations of zebra mussels be removed from the subject vessel's hull as soon as is practical to preclude further corrosion.
